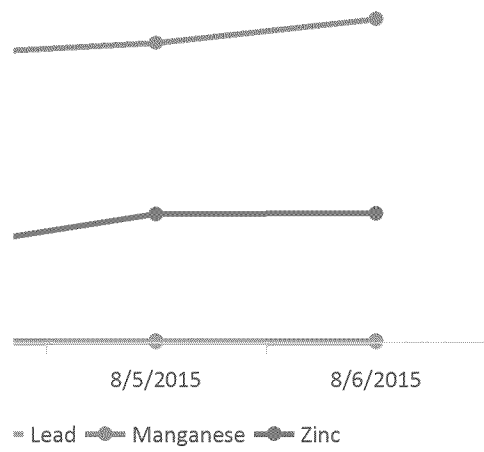
on: A68

Location ID	Date Sampled	Cadmium	Copper	Lead	Manganese	Zinc
A68	8/5/2015	0.828	3.45	0.232	737	199
A68	8/5/2015	0.815	3.16	0.283	727	238
A68	8/5/2015	0.974	3.52	0.82	757	324
A68	8/6/2015	0.85	3.26	0.329	817	326
